LOWER CONNECTICUT RIVER BASIN
HADDAM, CONNECTICUT

SCOVILL RESERVOIR DAM
CT 00431

PHASE I INSPECTION REPORT
NATIONAL DAM INSPECTION PROGRAM

DEPARTMENT OF THE ARMY
NEW ENGLAND DIVISION, CORPS OF ENGINEERS
WALTHAM, MASS. 02154

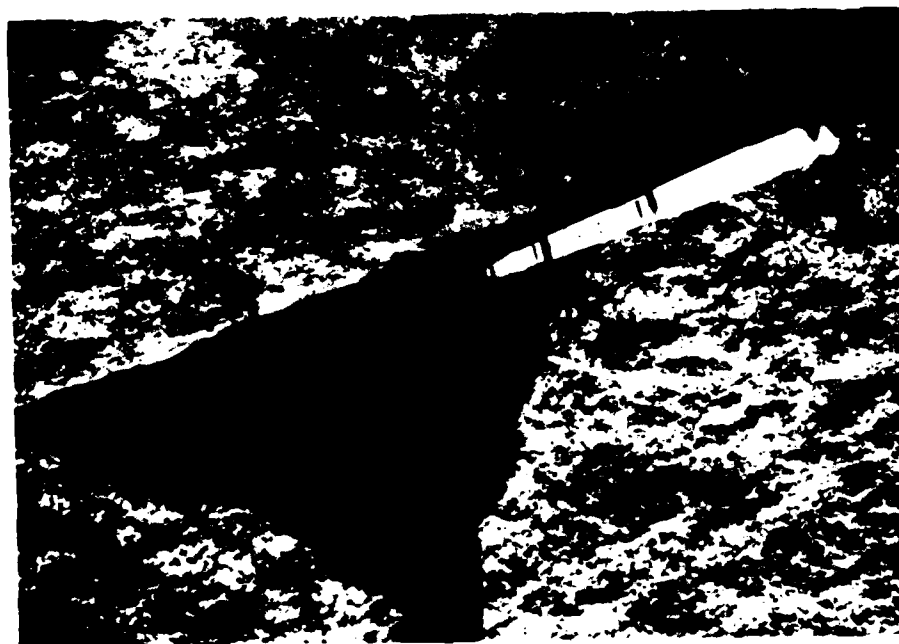
PHOTO #12: Void in stone masonry wall that forms the
downstream face. (Rule extended 4 ft.)
